# Memorandum

**Re:** Olde Club Fire and Structural Hazards.

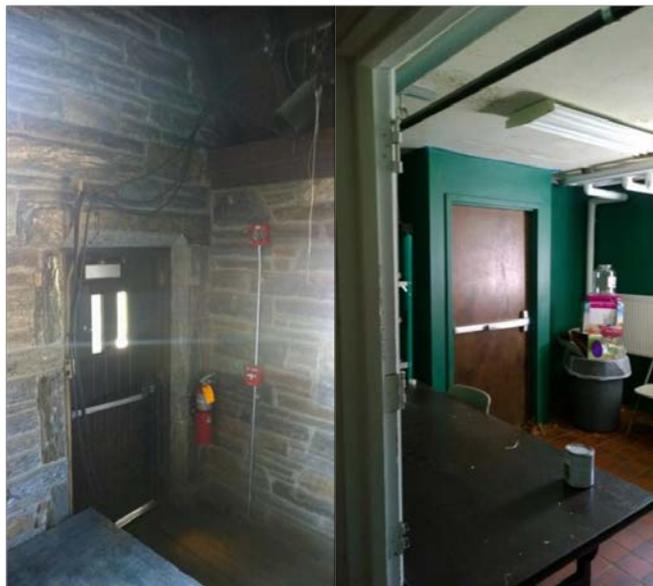
Many students believe there is only one exit from the building, while few know that there are in fact three. The main exit has an unilluminated<sup>1</sup> exit sign, while the other two simply have no exit signs at

<sup>1</sup> VIOLATION: International Fire Code (incorporated into PA Fire Code) Section 1011.2, p 118

all<sup>2</sup>. The downstairs exit, seen above right, cannot be easily seen from the assembly area downstairs and there is nothing marking it as being anything other than a broom closet. The exit path is frequently blocked by tables used for preparations of drinks. The upstairs back exit, seen above left, is also not marked. Note also the fire alarm notification appliance is heavily damaged near the upstairs back exit, and has been since at least October<sup>3</sup>. It could be safely assumed that a fire or a report of a fire would cause a panic, and many students, in a moment of panic in concert with potential intoxication, would rush to exit through the main exit only. This raises serious doubts as to whether Olde Club could, on a busy night, be at all safely evacuated.

<sup>2</sup> VIOLATION: Ibid Section 1011.1, p 118

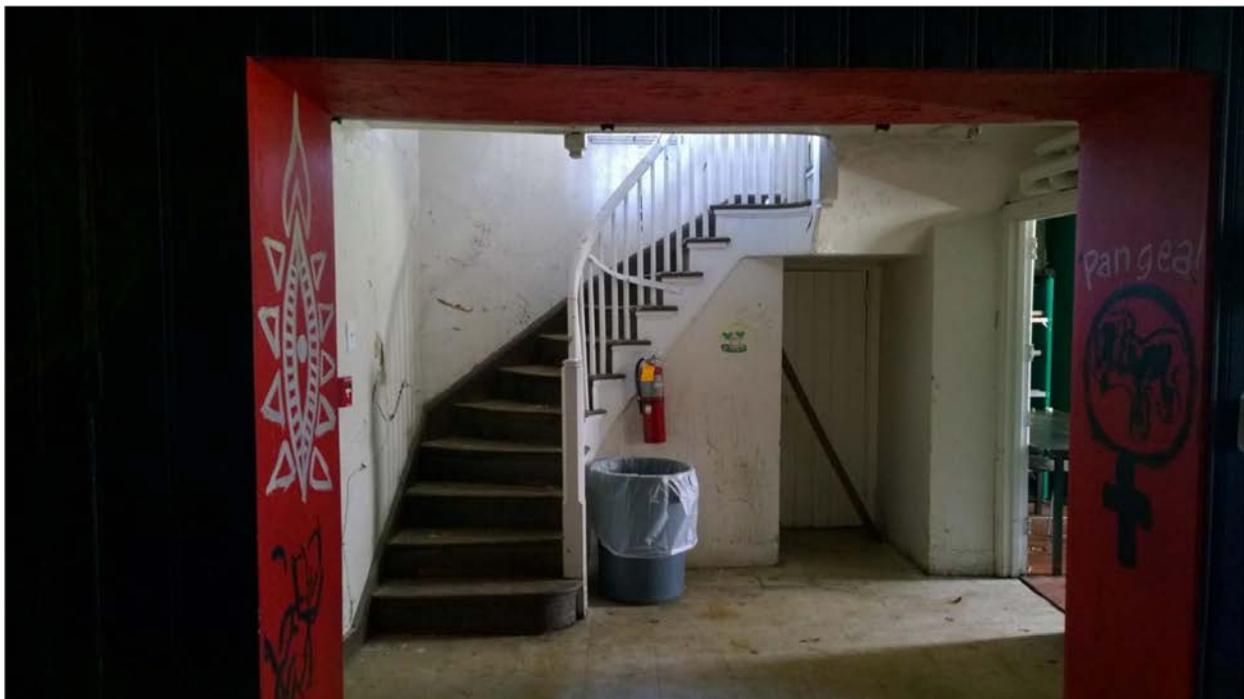
The main stairwell joining the ground-level dance floor and the basement-level dance floor is perhaps the most immediate hazard to students. The stairwell has a minimum width of 31 inches. By International Fire Code, 0.3 inches of stairwell width is required for each occupant of the building, so the current stairwell supports a theoretical maximum of 103 students safely. This occupancy has been and is often exceeded during busier parties. Furthermore is no illumination in the stairwell should the party hosts turn off the light switch, and there is no emergency illumination available whatsoever.<sup>4</sup> I personally have observed four falls on these stairs (which frequently clog with partygoers on Saturday

nights, as the bathroom is mid-flight), three of which involved strikes to the head. These stairs serve as the only commonly known means of evacuation for downstairs occupants, and an attempt to use them as such would likely have dire consequences.

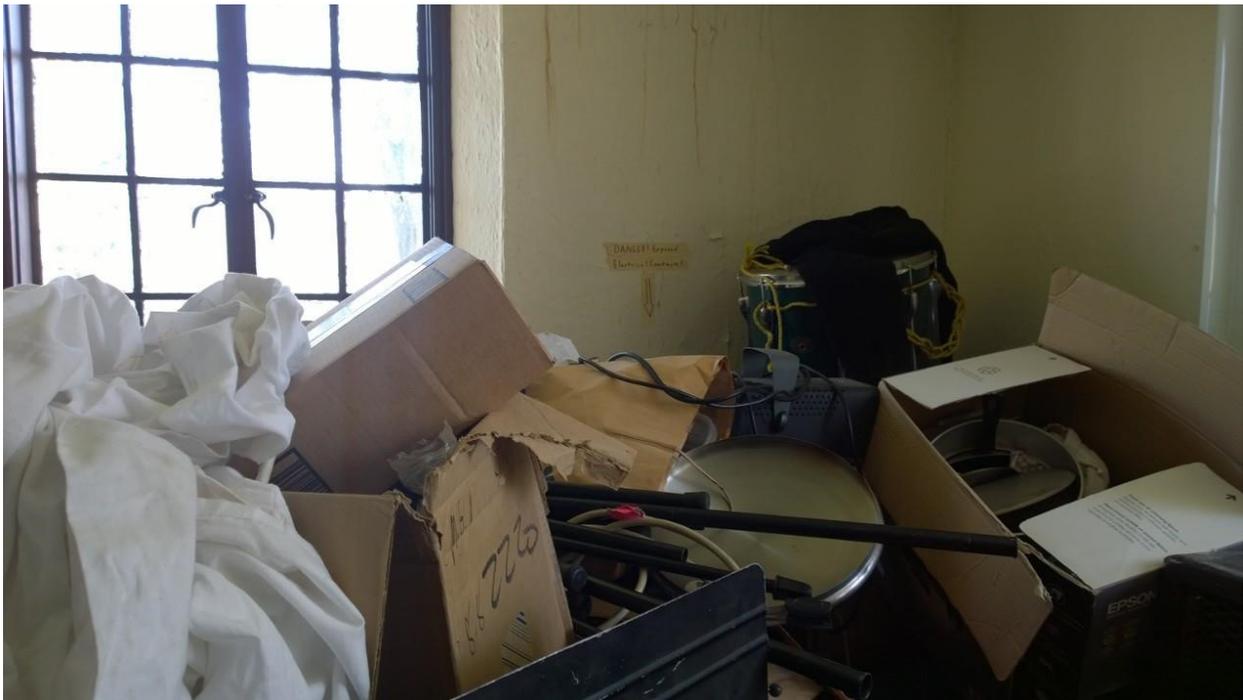
*1- The Storage Room in Olde Club adjacent to main assembly area*

The storage room is packed with equipment and packaging – much of it old, dry, and paper-based. The masking tape visible on the wall in the photo above reads “**DANGER! Exposed Electrical Contacts!**” handwritten in Sharpie. Paper boxes rest on top of whatever the electrical hazard is.

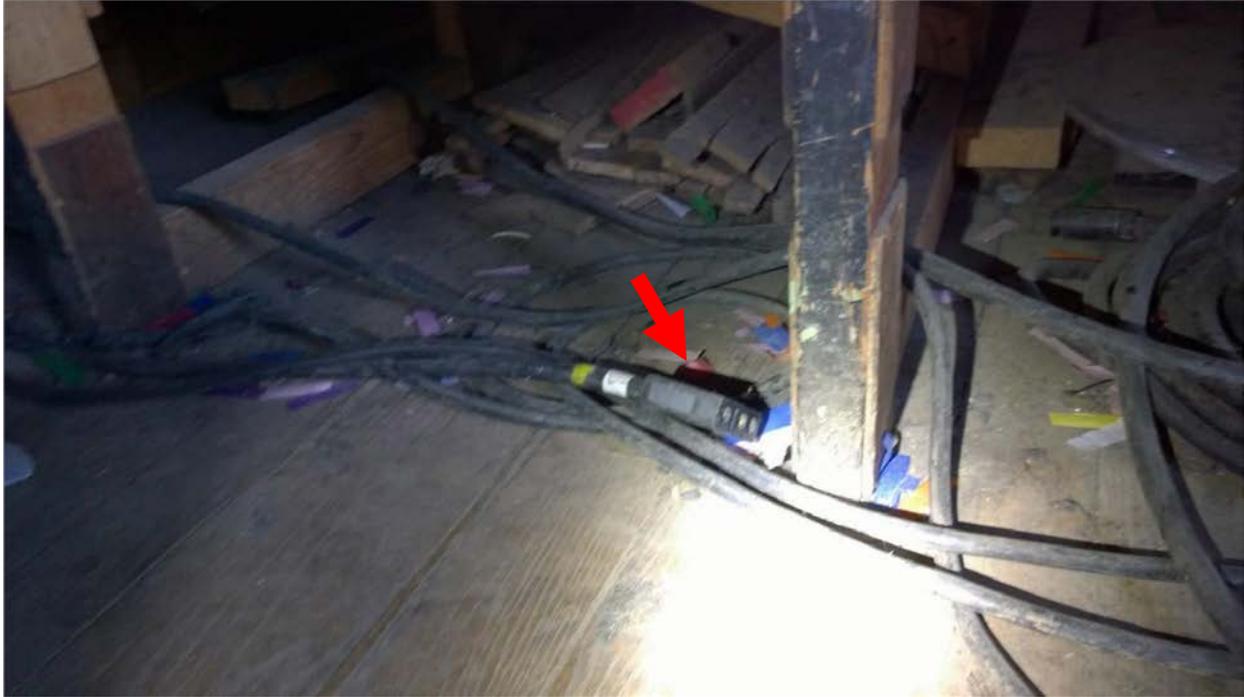
The area underneath the stage is packed with dry lumber and paper. High voltage<sup>5</sup> electrical cable from the lighting system runs throughout the area under the stage, and as is visible in this photo, sometimes has exposed contacts sitting next to piles of kindling. An accidental short of this connector with, say, a conductive fluid like water or beer could generate arcs of electricity or sparks.

<sup>5</sup> Note: Upon discussion with electricians, my original characterization of 'High Voltage' is an inaccurate statement, these lighting cables carry standard 120V electricity. That said, this is still enough to cause an arc capable of starting a fire.

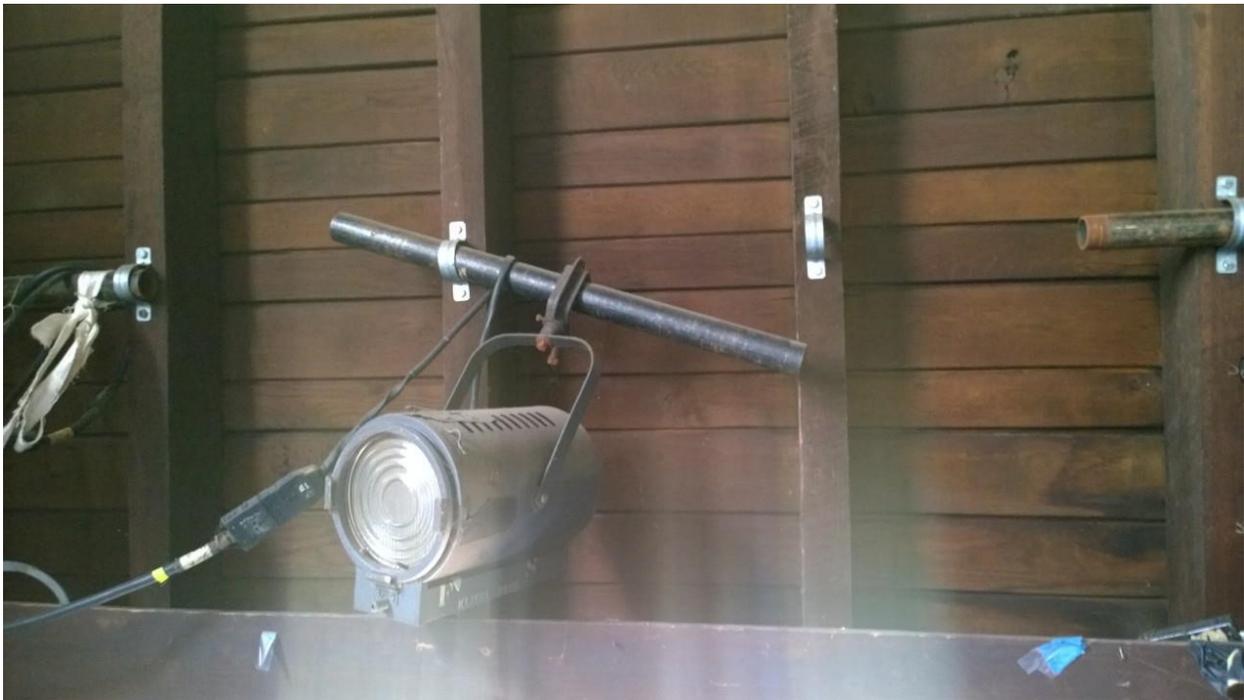
The cross-braces supporting the stage have in many areas fallen off or snapped, causing the frame structure underneath to deflect dangerously under load. Because of the significant out-of-plane deflection experienced by the wooden frame, I can tell you the stage is in **imminent danger of collapse**, particularly under the significant dynamic loads experienced during dance parties.

The lighting system is poorly maintained, and one of the Fresnel fixtures is literally one nudge away from falling. The pipe supporting it has come out of one of its brackets, so the only thing keeping this 20 pound piece of glass and metal (that gets hot enough to cause severe burns and ignite wood and paper) is the connection between the fixture and the cord it is plugged into.
